ARBOR LANDING, HOA

CHESTER, VIRGINIA

INTERACTIVE RESERVE ANALYSIS

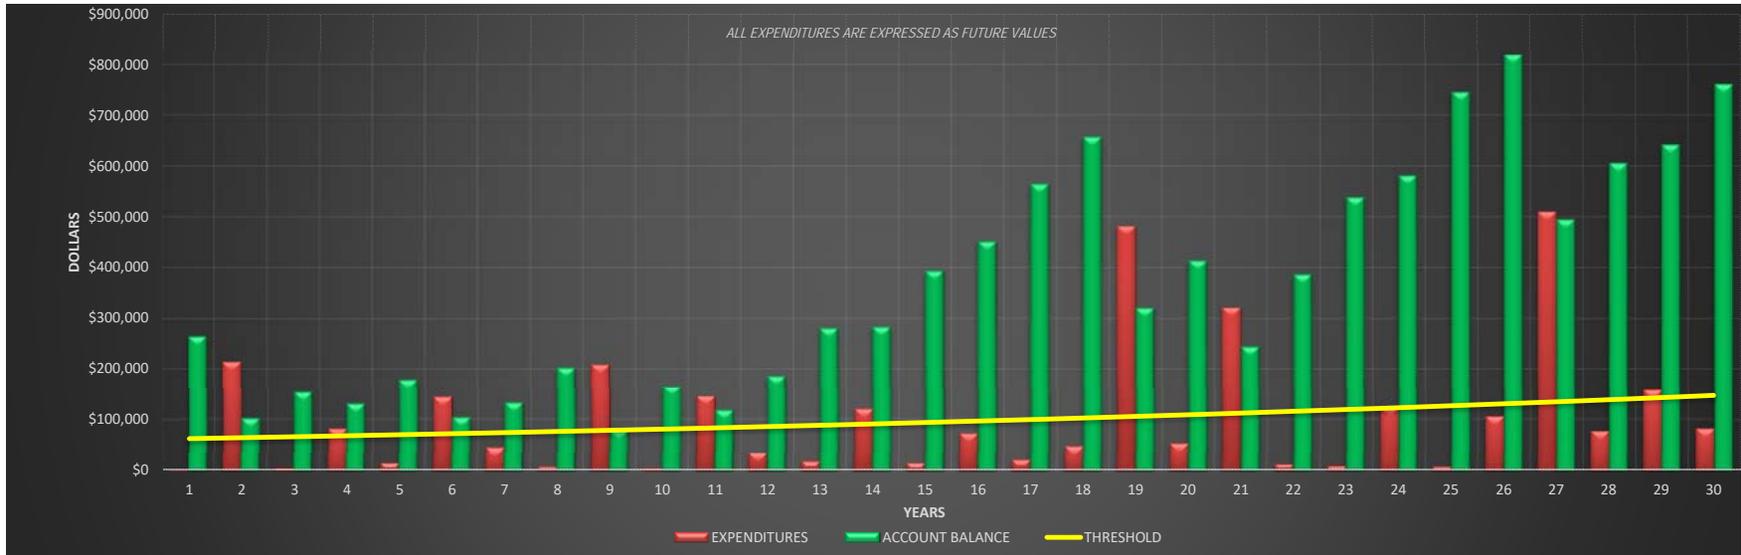
EXPENDITURE | 2019 | 2020 | 2021 | 2022 | 2023 | 2024 | 2025 | 2026 | 2027 | 2028 | 2029 | 2030 | 2031 | 2032 | 2033 | 2034 | 2035 | 2036 | 2037 | 2038 | 2039 | 2040 | 2041 | 2042 | 2043 | 2044 | 2045 | 2046 | 2047 | 2048

Inflation rate historical period; <u>select year</u>:	3	years	Annual escalation to the contribution per year, if any:	7.5%	75
Anticipated annual construction inflation rate:	3.08%	per year			
Threshold Balance to be Maintained in Account:			Annual Contribution in Year:		
A selected minimum balance of:	\$0	OR	2019	\$47,064	\$47,064
Total of Per-Occurrence Replacement Costs, times:	5.0%	50	2020	\$50,594	\$50,594
			2021	\$54,388	
			2022	\$58,467	
			2023	\$62,853

In real life, communities combine or "pool" their reserve funds into one account or a few group accounts. This allows for the flexibility to respond to the needs of any component when they vary from the exact projections for that component (the typical situation). The Cash Flow Method of reserve funding accommodates these inevitable variations in reserve expenditures and also allows us to introduce inflation rates, earnings rates, and graduated or variable rate funding plans, to produce a more useful, realistic and fair way to fund your reserve account. The Cash Flow funding analysis for this account is provided on the following pages.
